Docket No. 424 – Development and Management Plan Inspection

The Connecticut Light and Power Company Certificate of Environmental Compatibility and Public Need for the Connecticut portion of the Interstate Reliability Project.

IRP Overhead ROW

Interim Week Inspection:

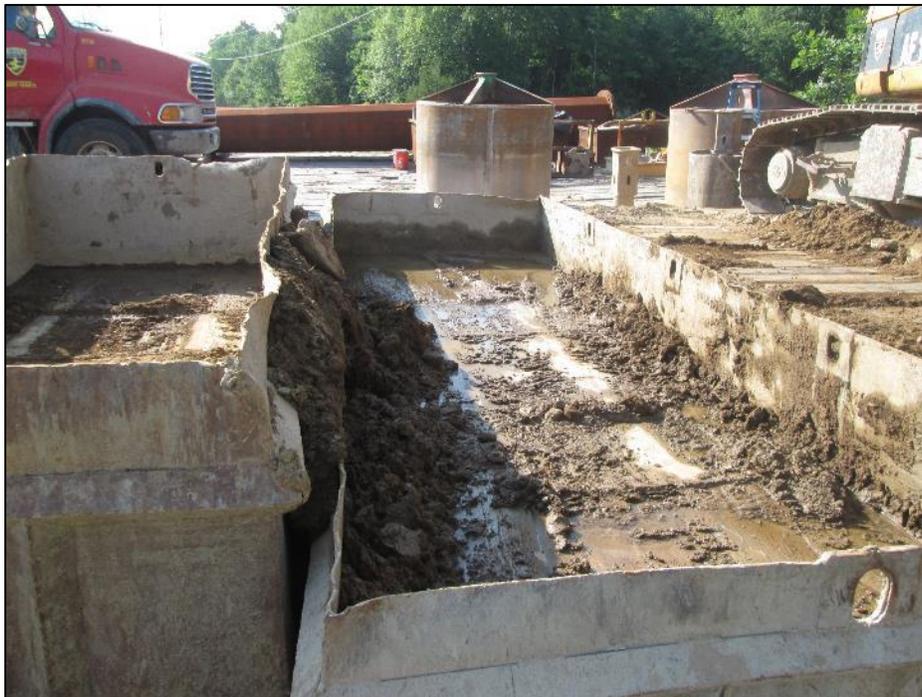
Photo #2: Spoils being contained in "spin off" containers at Str 15. (8/7)

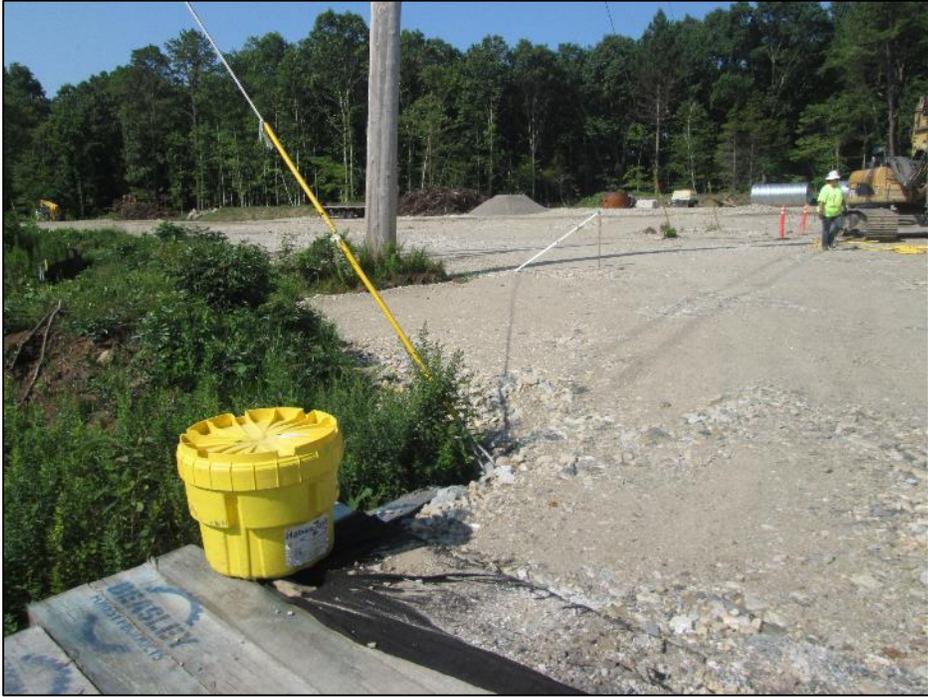
Photo #3: Spill kit noted on site at Str 42. (8/7)

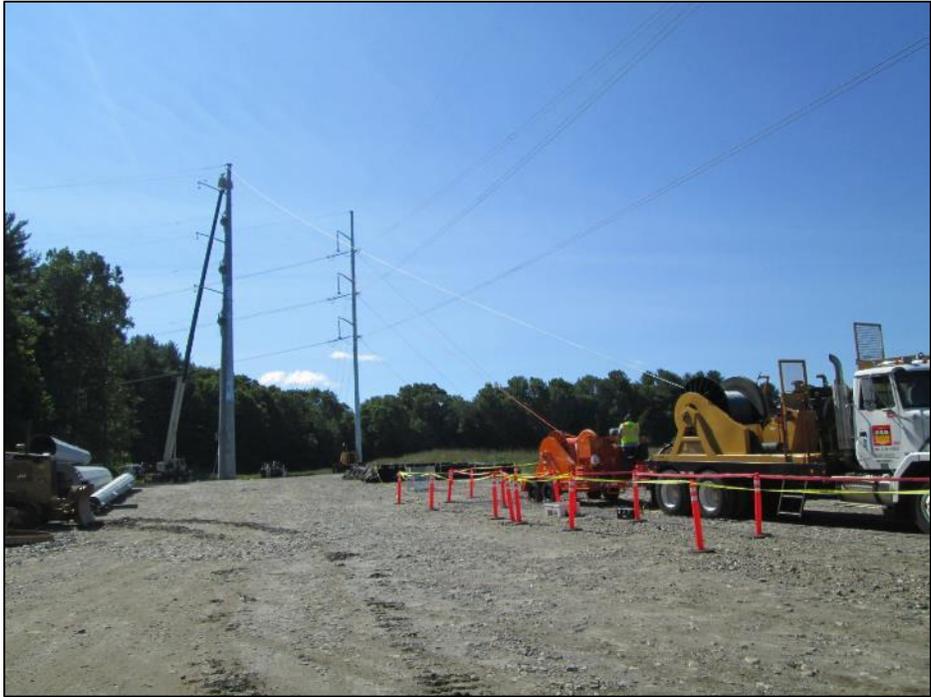
Photo #4: Conductor pull at Str 83.

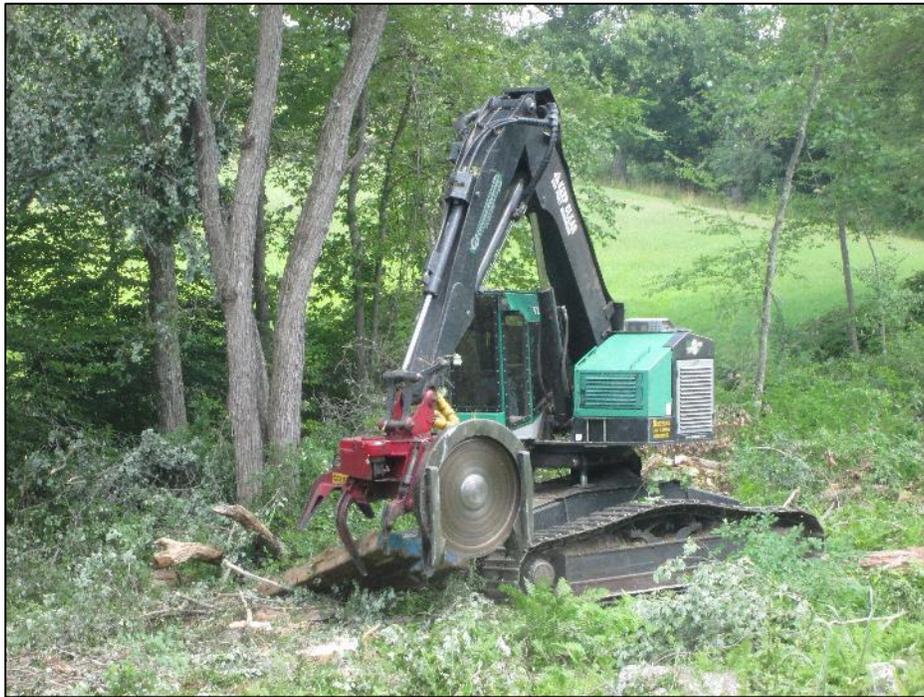
Photo #5: Feller/buncher using wetland mats to avoid unnecessary rutting at Str 138. (8/7)

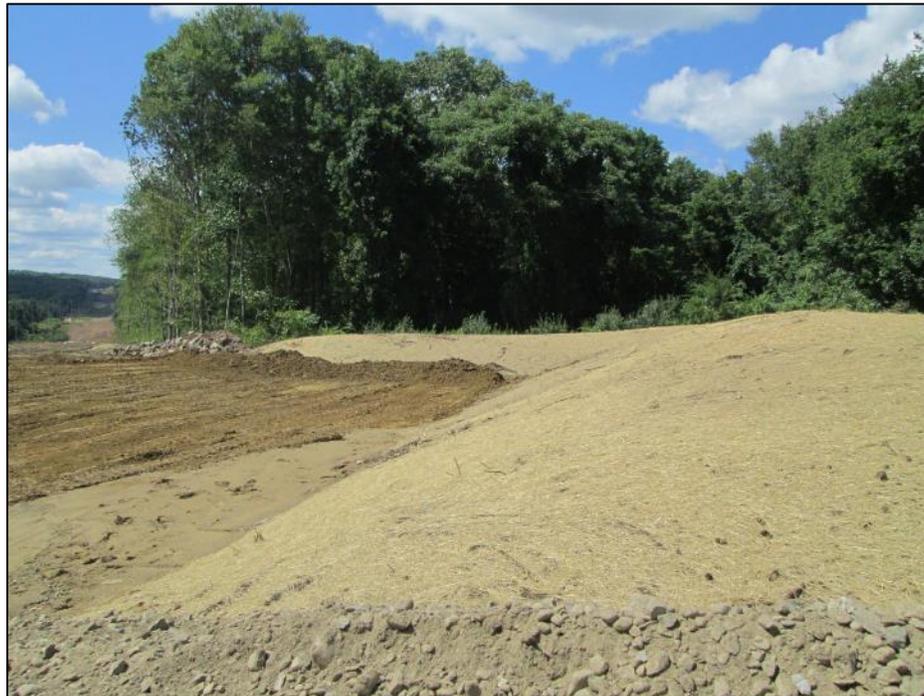
Photo #6: Blown straw erosion control measures at Str 151.

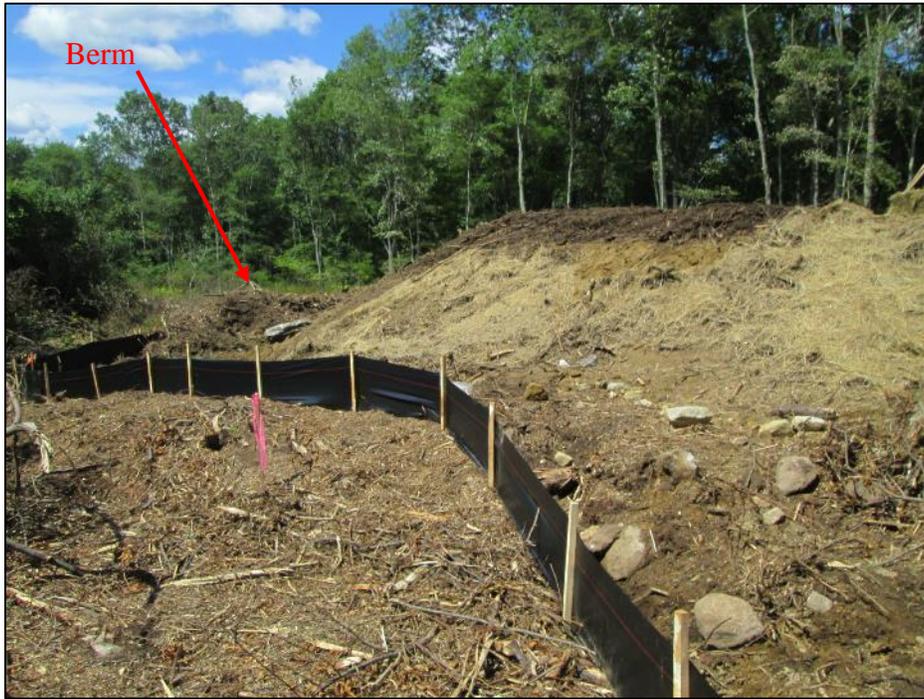
Str 151: Building soil berms for additional erosion control protection. (Photo 7)	NA	NA
Inland Wetland and Watercourse encroachment and mitigation	Interim Week (8/7)	Mat installations in wetland areas are in accordance with the BMP Manual.	Continue to follow this procedure.	NA
		Str 138: Feller/buncher using wetland mats to avoid unnecessary rutting in wet areas. (Photo 5)	Continue to follow this procedure.	NA
	Bi-Week (8/14)	Mat installations in wetland areas are in accordance with the BMP Manual.	Continue to follow this procedure.	NA

Photo #7: Building of berms at edge of Str pad 151 for additional sedimentation support.

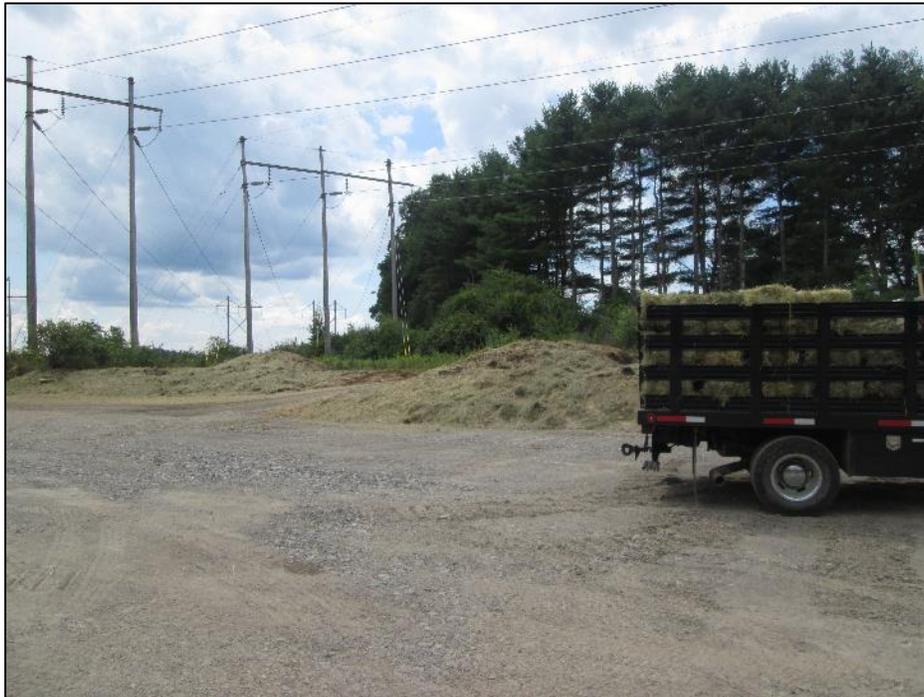
Photo #8: Blown straw erosion control measures on exposed topsoil up-line of Str 245. (8/7)

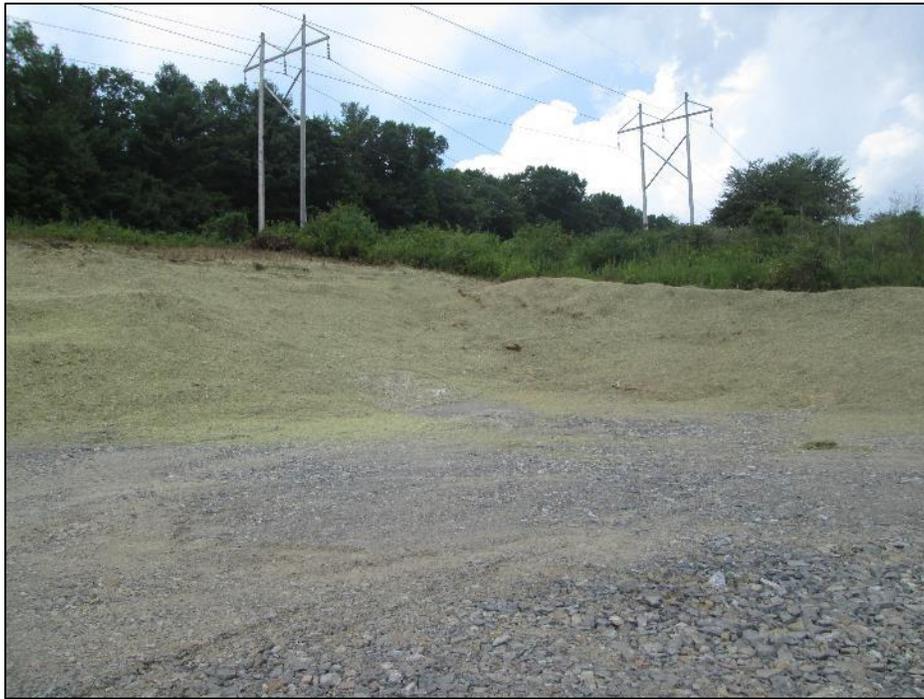
Photo #9: Blown straw on exposed topsoil at Str 246. (8/7)
